# COMBINED FIRE AND HEALTH & SAFETY RISK ASSESSMENT.

Address of premises:	Ermin Mews, Stratton St Margaret, Swindon, SN3 4PP
Responsible Person:	Ermin Mews Management Company Limited
Duty Holder:	Block Management Limited
Person(s) consulted:	No occupier or other relevant person available to consult.
Assessor:	Rob Cockburn
Report validated by:	John Godfrey, GIFireE.
Date of fire risk assessment:	20 <sup>th</sup> September 2024, Reviewed September 2025
Date of previous fire risk assessment:	N/K
Suggested date for review:	September 2026

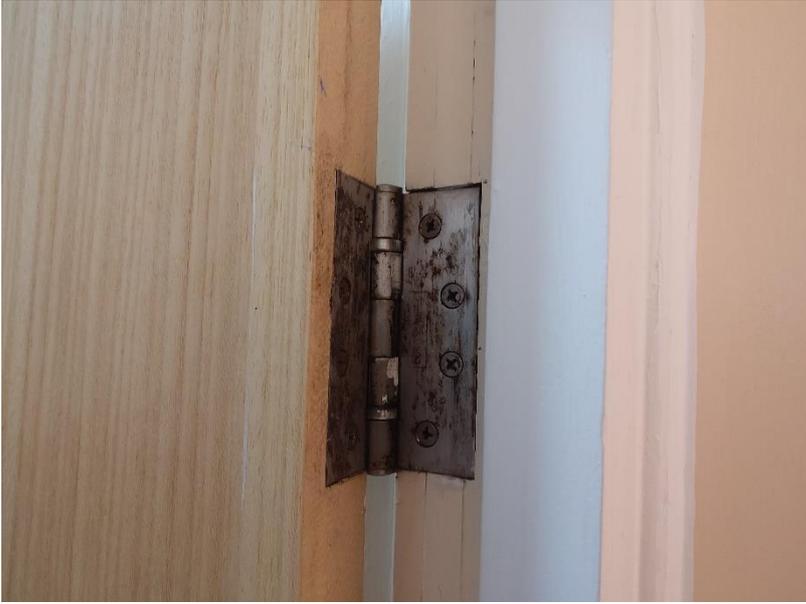
<p><b>04</b></p>	<p>As per section 33.2 of Fire Safety in Purpose-Built Block of Flats a type 1 fire risk assessment requires us to conduct a fire door survey on a sample of flat front doors. Doors to flats 2 and 12 were surveyed during this sample which appeared to have intumescent seals only.</p> <p>It is essential that each flat entrance door is a suitable fire door, providing a minimum of thirty minutes fire resistance, hung on three grade 13 hinges and having a functioning self-closing device fitted that positively closes the door on the latch, together with smoke and intumescent seals. It is recommended therefore that the RP instruct a suitably qualified and competent contractor to conduct a fire door inspection to all flat entrance doors and communal area doors providing advice on suitability. Any shortcomings identified by this inspection should be addressed as a priority by upgrading or replacing the door.</p> <p>Flat entrance doors, communal area doors, the seals and the self-closing devices should then be subjected to an annual inspection and maintenance schedule.</p>

<p>3</p>	<p>C</p>	<p>Action required</p> <p>Apartment doors belong to individual apartment owners.</p> <p>Information provided on website including importance of fire doors.</p>

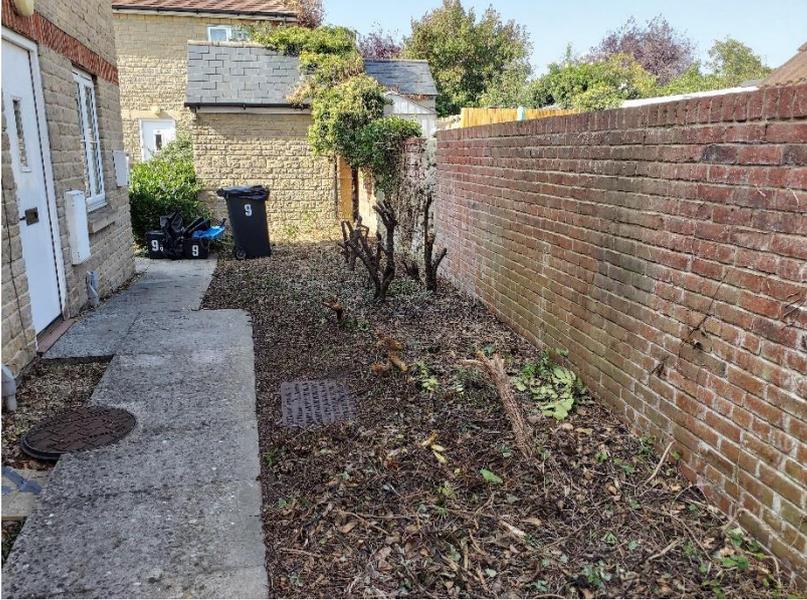
• Are there any other safety issue concerns?	NO
31.2	Comments and hazards observed:	
<p>The surrounding areas of the premises including hard and car parking areas were found to be in good visual condition with paved and Tarmacked surfaces reasonably level and free from major indentations or potholes. These areas should be periodically inspected by the RP and the results of each inspection recorded.</p> <p>It was noted during this fire risk assessment that the landscaping around the premises had multiple exposed tree stumps which have been cut back. It is recommended that the RP have these removed in order to removed trip hazards.</p>

<p>13</p>	<p>It was noted during this fire risk assessment that the landscaping around the premises had multiple exposed tree stumps which have been cut back. It is recommended that the RP have these removed in order to removed trip hazards.</p>

<p>2</p>	<p>B</p> <p>Ongoing action required RP is undertaking a programme of works to restore the communal grounds.</p>
-----------	---	----------	---
